**The Olympia Odos Independent Engineer**

**Subject: Response to State's letter B/E2/Φ4/228847, 24/07/2023**

| | EKPPT Motorway<br>MONITORING REPORT | Report No.: | M0053 | |
| Structure/ Installation: K603 | kp1 [to kp2]: 208+800 | | | Ref.kp: EKPPT |

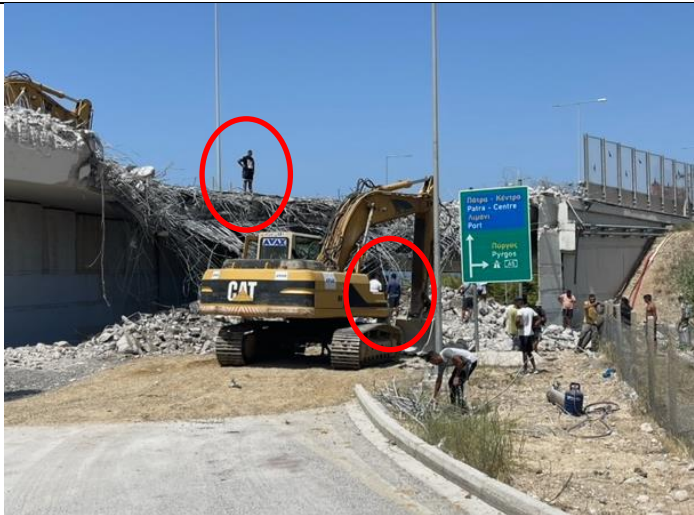
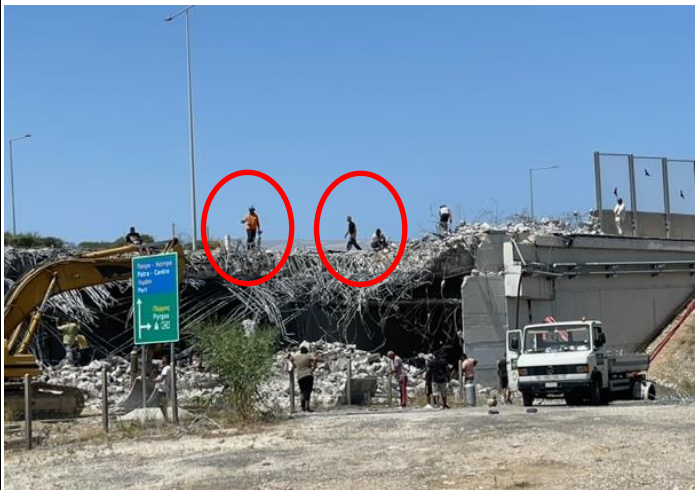
| Finding No. | Description | Reference document(s) | ANC <sup>(1)</sup> | ACT <sup>(2)</sup> |
|---|---|---|---|---|
| 1. | <p>The present Monitoring Report is an outcome of the ongoing works of the Demolition of the Left Part of the Deck of Structure K603.</p> <p>During Demolition Process, and after the implementation of the approved TTA, the entering of <u>unauthorized people inside the demolition zone</u>, from both the Motorway level, as well as from the street below (Diodorou st) has been noted, as shown in the following pictures. The persistent Constructor's effort to operate within the Risk Assessment guidelines inside the demolition zone, requesting from them to leave, was unsuccessful.</p> <p>Furthermore, it was noted that these people were - during the IE's presence - climbing the demolition debris, flame cutting reinforcement &amp; moving next to demolition heavy machinery (e.g. hydraulic hammer), drastically increasing the risk of an accident.</p> <p>The aforementioned is considered as being of potentially catastrophic consequences on the Risk Assessment Matrix, as it combined a deviation from the Project Quality Procedures (concerning the relevant WMS Submission for Demolition of Deck), and a Safety Guidelines deviation (unauthorized people inside demolition zone).</p> <p>Therefore, a <b>SAF</b> opens.</p> <p>Finally, the IE recommended that works should not advance under aforesaid conditions and the request of the assistance by the police was proposed to the Constructor, in order to achieve completing the aforementioned activity with no further incident.</p> | <p>WMS PBX GEN K603 AW3 G 06084 B-</p> <p>RPT K603 DEN F 60305 F-</p> <p>DRW PBX CON K603 DEN F 60301 / F-</p> | SAF | |

Photos 1 & 2 | Unauthorized people inside the demolition zone | 22/07/2023

The next day, Saturday 22.07.2023, (as noted by a new on-site inspection of our engineer), it was observed that despite the existence of delimitation – signage – blocking of the working zone with the installation of concrete safety barriers, about 15 - 20 unauthorized persons had entered the demolition zone. The above-mentioned persons, ignoring the relevant prohibitions, attempted, in parallel with the ongoing works of the Constructor, to cut off steel concrete reinforcement with the use of a flamethrower, moving right below the deck of the bridge under demolition. Immediately, our engineer recommended to the Supervising Engineer - Safety Officer of the Constructor the immediate stop of the works in order to address the unsafe situation.

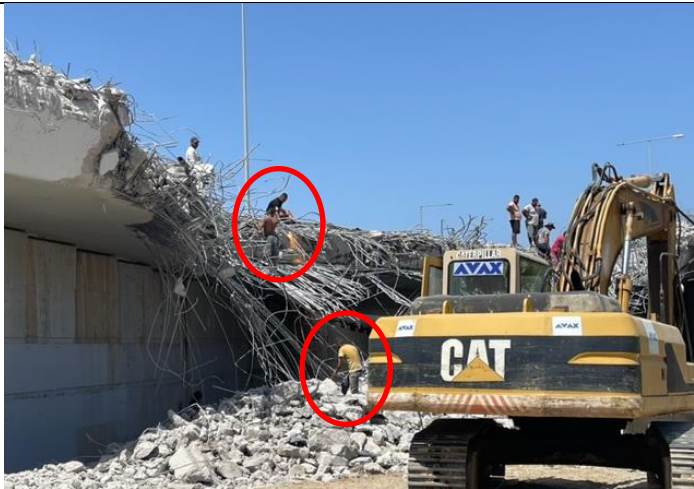
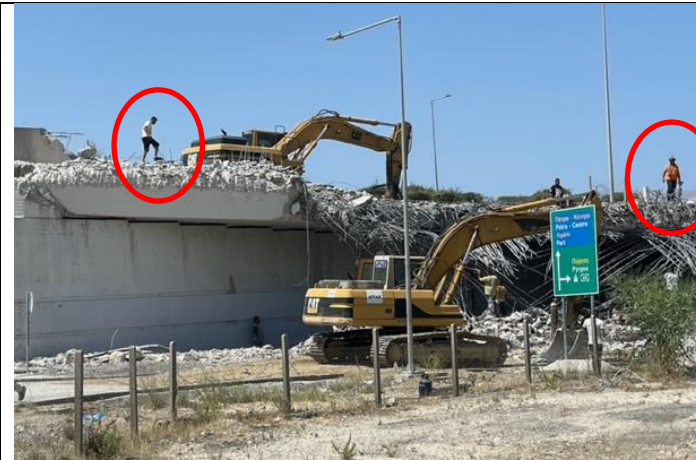
Photos 3 & 4 | Unauthorized people inside the demolition zone | 22/07/2023
